DEPARTMENT OF TRANSPORTATION**DIVISION OF ENGINEERING SERVICES**

Contract #: 04-0120F4Cty: SF/ALA Rte: 80 PM: 13.2/13.9File #: 69.28**WELDING INSPECTION REPORT****Resident Engineer:** Pursell, Gary**Address:** 333 Burma Road**City:** Oakland, CA 94607**Report No:** WIR-003062**Date Inspected:** 01-Jun-2008**Project Name:** SAS Superstructure**OSM Arrival Time:** 1400**Prime Contractor:** American Bridge/Fluor Enterprises, a JV**OSM Departure Time:** 2300**Contractor:** Zhenhua Port Machinery Company, Ltd (ZPMC), Changxing Island **Location:** Shanghai China

Bridge No: 34-0006**Component:** Tower / OBG**Summary of Items Observed:****Tower Shop Bay 2**

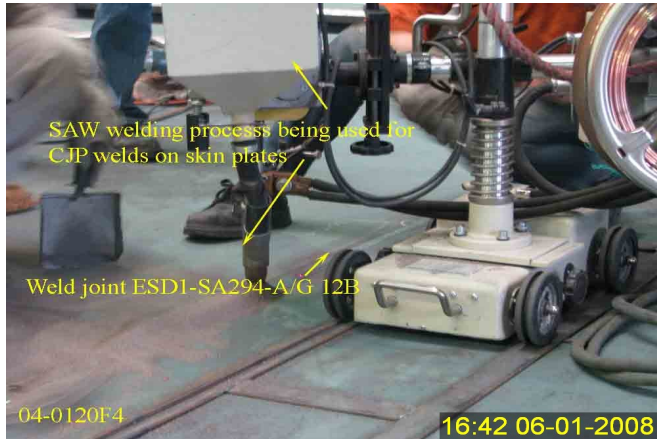
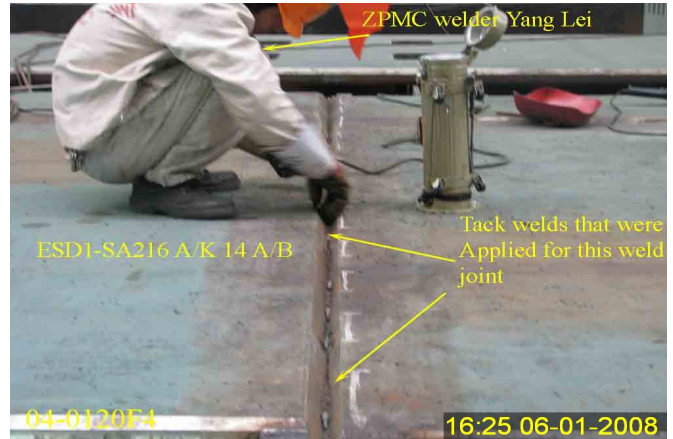
operations in this bay and monitoring welding parameters and in progress progression. Component FB015-011 was in process of being welded for joint 045 using FCAW process. ZPMC welder Hong Shuili was performing this function under WPS-B-Y-2232-Tc-U4b-T. Also noted was fit-up of flange to web plate being tack welded under WPS-B-P-2112-2F-SMAW Mr. Wang-Pang was present during this operation to monitor weld parameters and progression.
